MEMORANDUM REPORT ARCCB-MR-00007

**A FRACTOGRAPHIC STUDY OF  
A CIRCA AD83 ROMAN NAIL**

**A. A. KAPUSTA  
J. H. UNDERWOOD**

MAY 2000

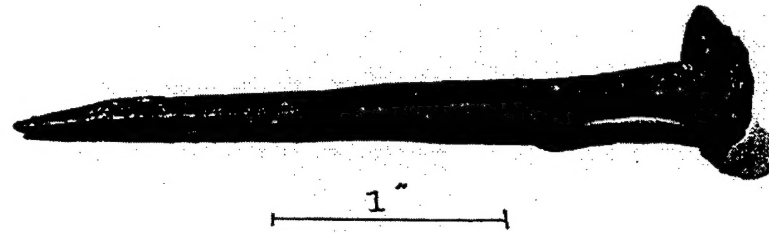
Measuring about 84-mm long with a disk-shaped head, the nail corresponded to one of group "D" as classified in the previous work. Figure 1 shows the as-received nail at 1X magnification, and reveals the roughly rectangular shape of the nail shank and the surprisingly light surface oxide layers discussed in the previous work.

Figure 1. A group "D" nail from the Roman fortress at Inchtuhil (1X).

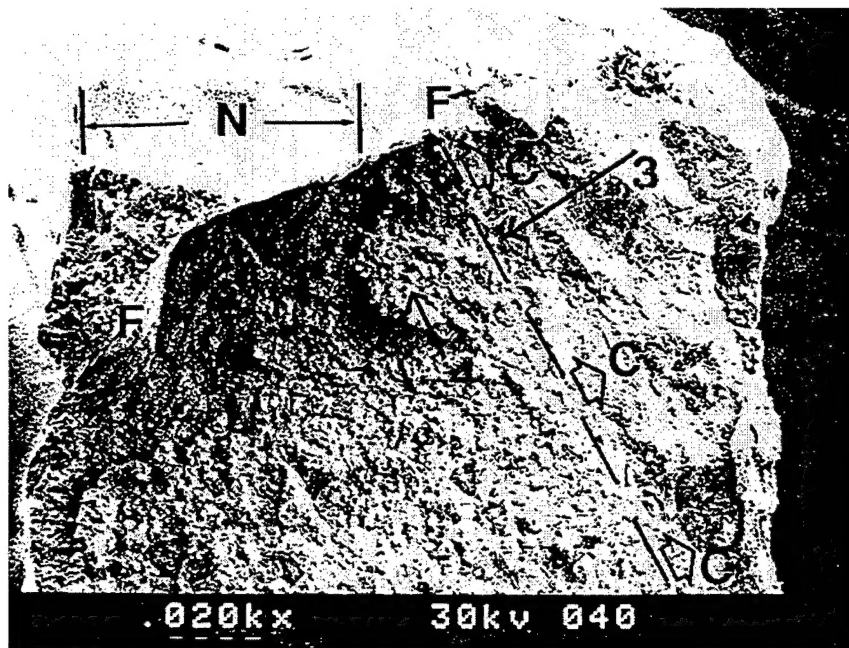
Figure 2 is a view normal to the fracture surface, and it shows that only a small portion of the laboratory-created fracture surface had initiated at the introduced notch, indicated by the letter "N." Most of the fracture had started at a preexisting transverse corner defect, "C." A preexisting longitudinal fissure, "FF," separates the laboratory-created fracture area that initiated at the corner defect and the area that initiated at the introduced notch. The preexisting corner defect and fissure were coated with a black (high-temperature) oxide, and they have a similar appearance to the internal defects seen in a longitudinal metallographic cross section of a group "D" nail shown in Figure 13 of Reference 1. Figures 3 and 4 (from locations shown in Figure 2) are from the oxide covered preexisting corner defect and the "clean" laboratory separation, respectively. The oxide obscures most other features in Figure 3. Figure 4 shows typical low-temperature transgranular cleavage, consistent with cleavage of sound, homogenous steel. Figure 5 is from a region most remote from the crack origin, and again shows transgranular cleavage, and a thin lip of tear dimples, "D."

Figure 2. Transverse fracture surface showing notch, corner defect, and fissure (20X).

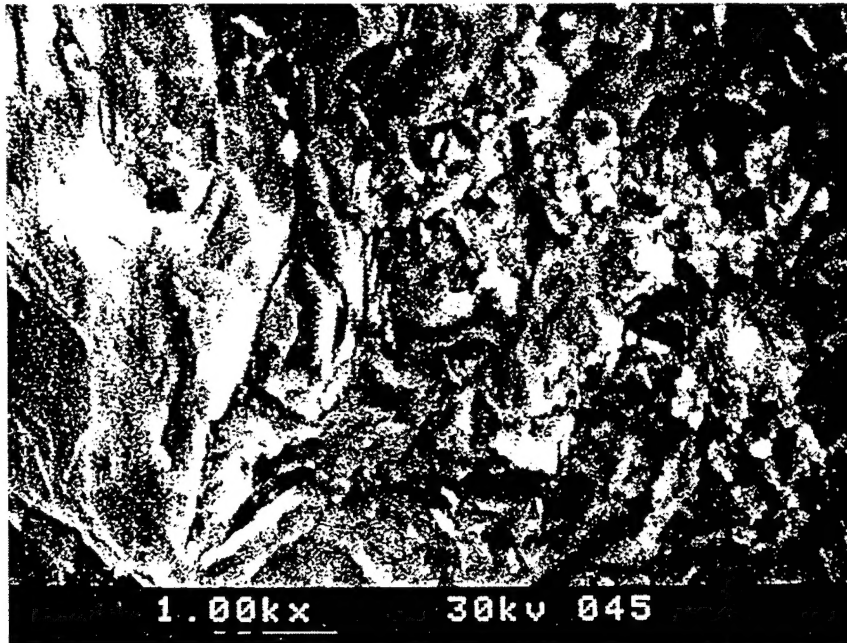
Figure 3. Oxide layer on preexisting corner defect (1000X).

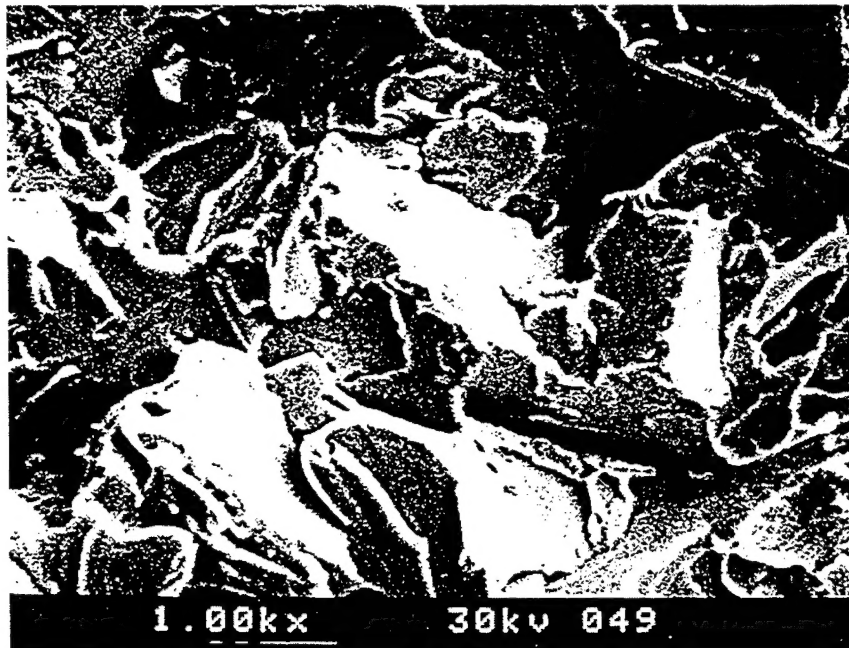
Figure 4. Low-temperature transgranular cleavage near crack origin (1000X).

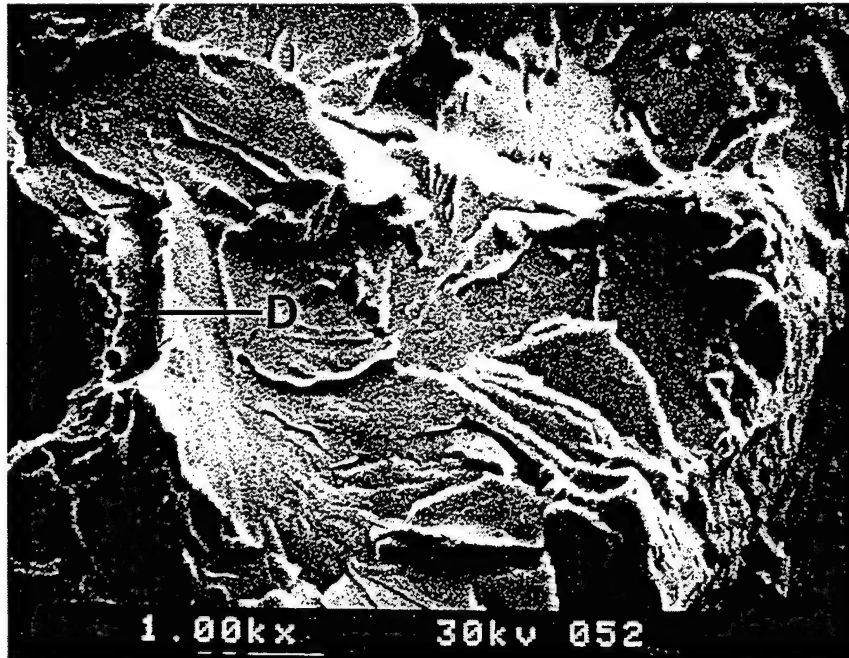
Figure 5. Low-temperature transgranular cleavage remote from crack origin (1000X).

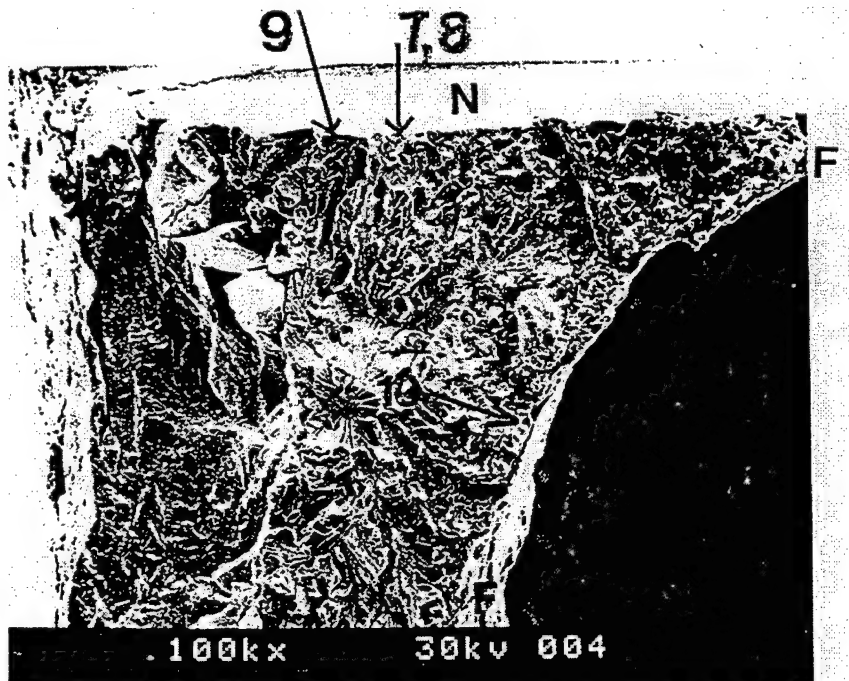
Figures 6 through 10 are from the laboratory-created fracture surface that initiated at the introduced notch, with the locations of Figures 7 through 10 noted in Figure 6. Figures 7 and 8, at 1000X and 5000X, respectively, show areas of transgranular cleavage immediately adjacent to the notch. Figure 9 shows curved river lines, "R," indicative of transgranular cleavage through preexisting cold worked metal adjacent to the notch, while Figure 10 shows oxide, "O," and small voids, "V," associated with the preexisting longitudinal fissure, "FF."

Figure 6. Transverse fracture surface near the laboratory-induced notch (100X).

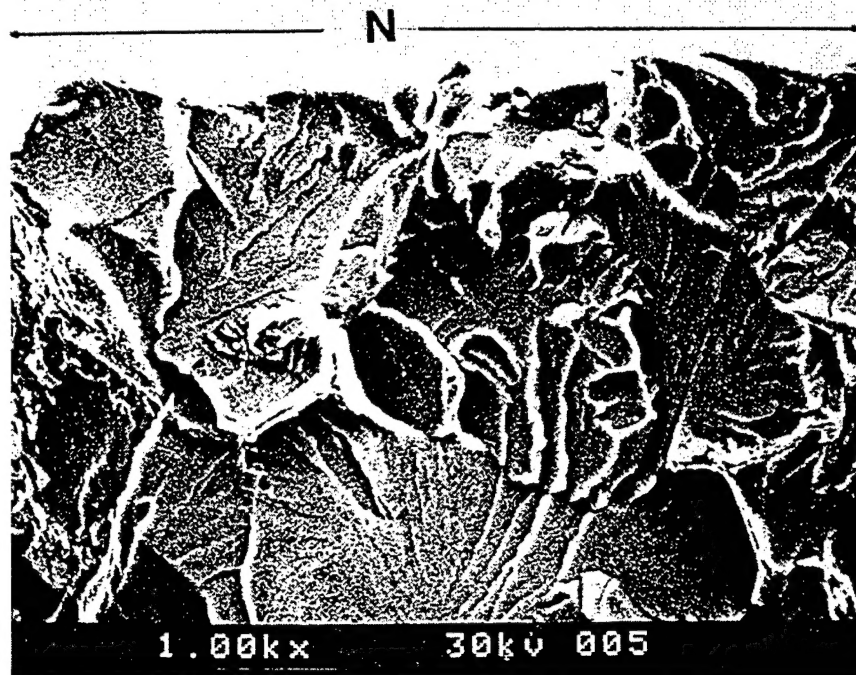
Figure 7. Low-temperature transgranular cleavage adjacent to notch (1000X).

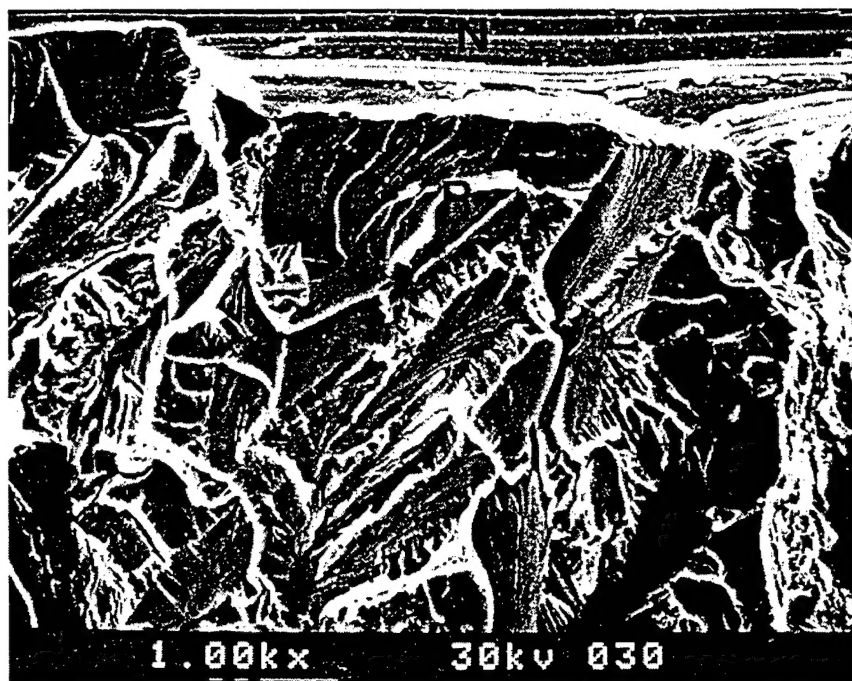
Figure 9. Curved 'river lines' indicating cold-worked metal (1000X).

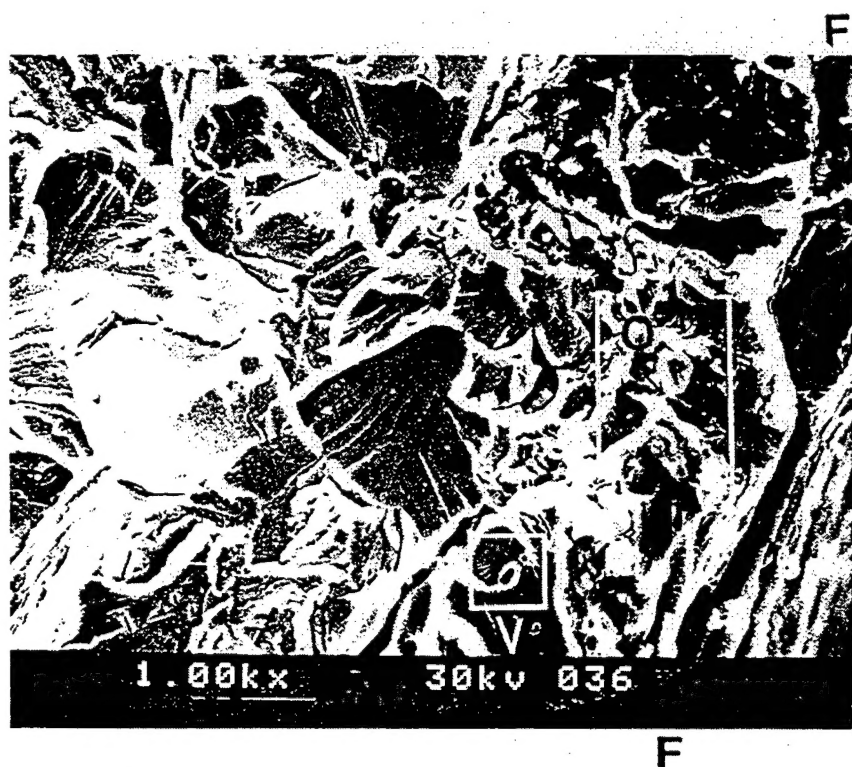
Figure 10. Oxide and voids indicating the preexisting fissure (1000X).
